Minerals Inspection Report

Report Date: 08/26/2014

Mine Name: South Farm	Permit Number: M/035/0034	Mine Status: Proposed
Operator Name: R.A. Johnson	Inspection Date: 08/18/2014	Permit Fees: Paid
Inspector(s): L. Heppler	Inspection Time: 2:30 PM	Bond Amount: \$14,620
Attendee(s): Blake Thomas-Herriman, Robert Johnson-Opt	Weather: Sunny, Dry	Bond Escalation: 10/15/2010
Inspection Purpose: Operator requested bond release		Prior Inspection: none

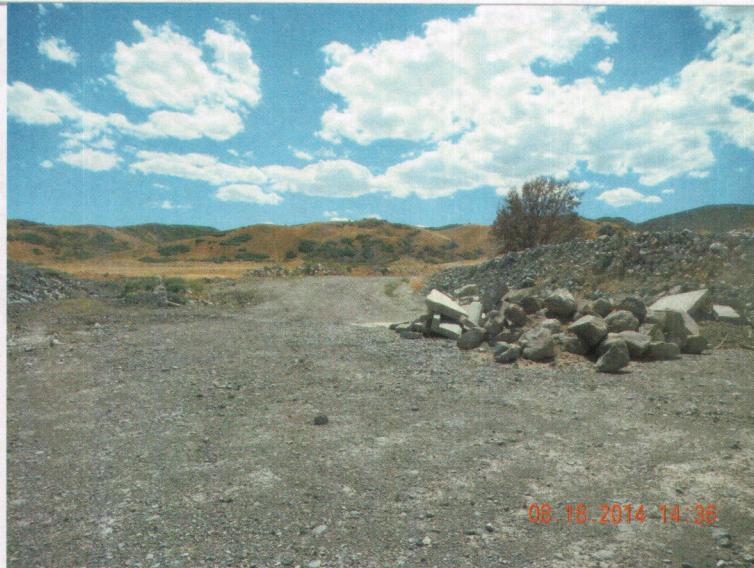
6. <i>Reclamation</i> No concurrent reclamation was noted at the time of inspection. Mine site is the future site of a Herriman City roadway	<input checked="" type="checkbox"/>	<input type="checkbox"/>

Un-reclaimed site

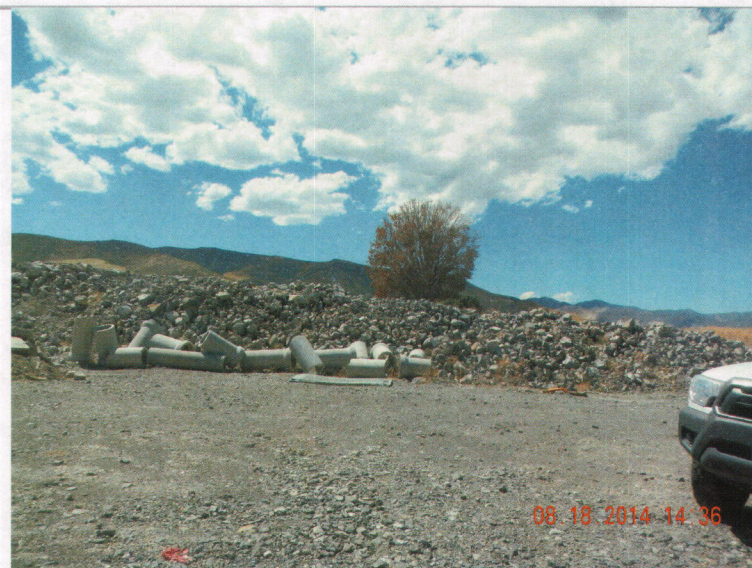
4. <i>Deleterious Material</i> Cast concrete pipe was on site - no rebar reinforcement in noted in pipe, no deleterious materail was noted	<input checked="" type="checkbox"/>	<input type="checkbox"/>

Cast concrete pipe on site

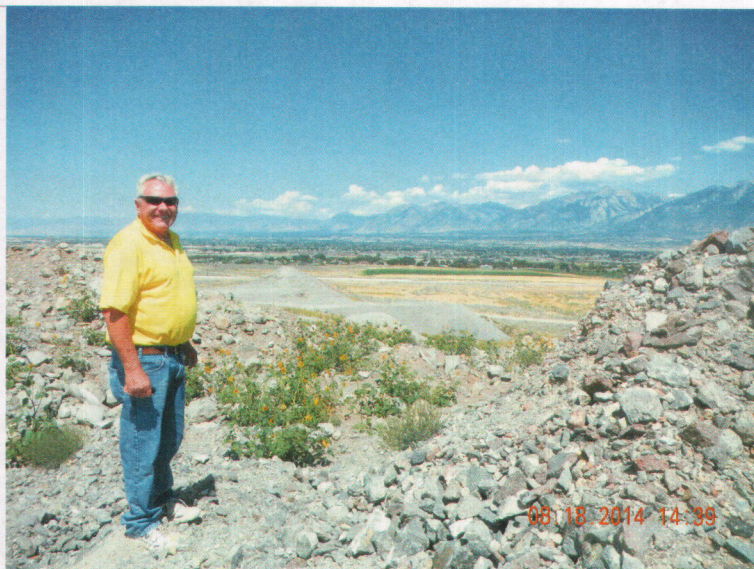
Operator at mine - Un-reclaimed site

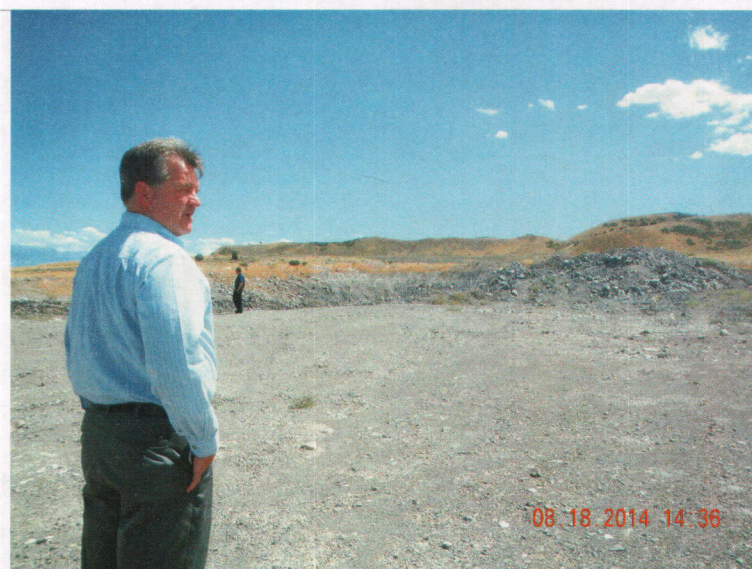
Un-reclaimed site
